FORM B - BUILDING

Form Number
1078

Address 11 Locust Avenue

Historic Name Rev. Thomas & Kate Thompson House

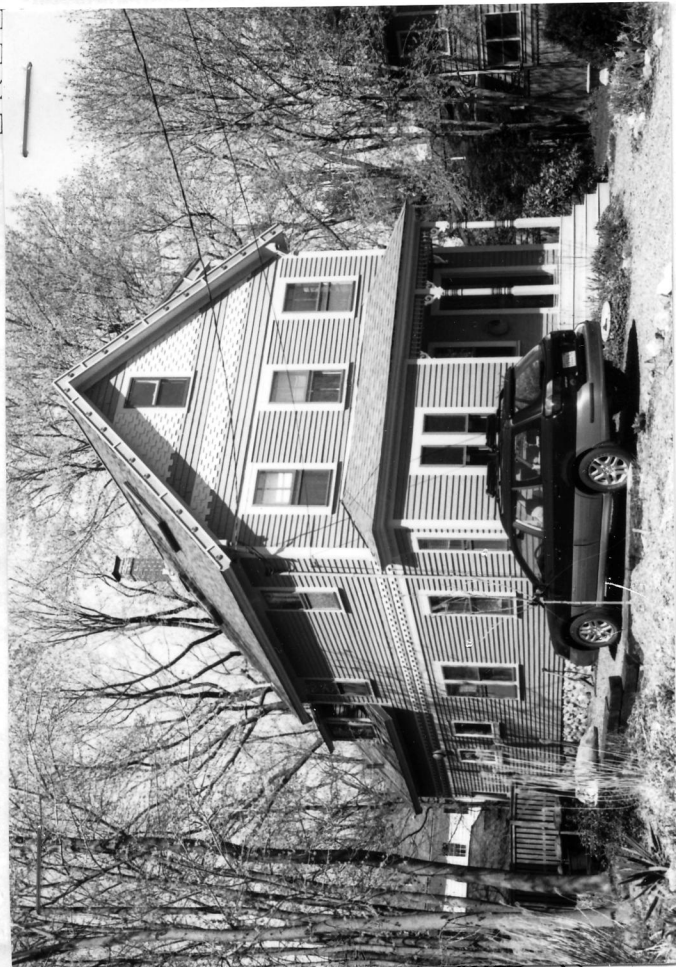
The house at 11 Locust Avenue is a simple, 2 1/2-story vernacular Queen Anne-style dwelling which displays a three-bay wide gablefront. Set above a rubble foundation, the house is sheathed in clapboards with decorative wood shingles in the front gable alternating staggered butt and regular patterns with a similar band extending along the side elevations between the first and second stories. Extending behind the main house is a 1 1/2-story wing aligned with the north wall and also set on a stone foundation with shingle trim. The raking molding on both the gablefront and the south shed dormer are decorated by pairs of raised circular medallions separated by lines. The ends of the raking are notched and are supported by decorative brackets with incised foliate designs and pendants.

The sidehall entrance contains a varnished wooden door separated into five raised panels with the two upper panels containing etched glass. Adjacent to the front door is a single 2/2 window. The gablefront is fronted by a single-story, hip-roofed entrance porch although the north half has been enclosed. The remaining open porch is supported by two turned posts with jigsawn brackets and a spindle frieze. The second floor of the facade is punctuated by three 2/2 windows with a single new 1/1 metal window in the attic.
